## BORESCOPE INSPECTION REPORT

REDUCTION GEARBOX  
TAURUS 60  
COLD END DRIVE

**GBE17-79058**

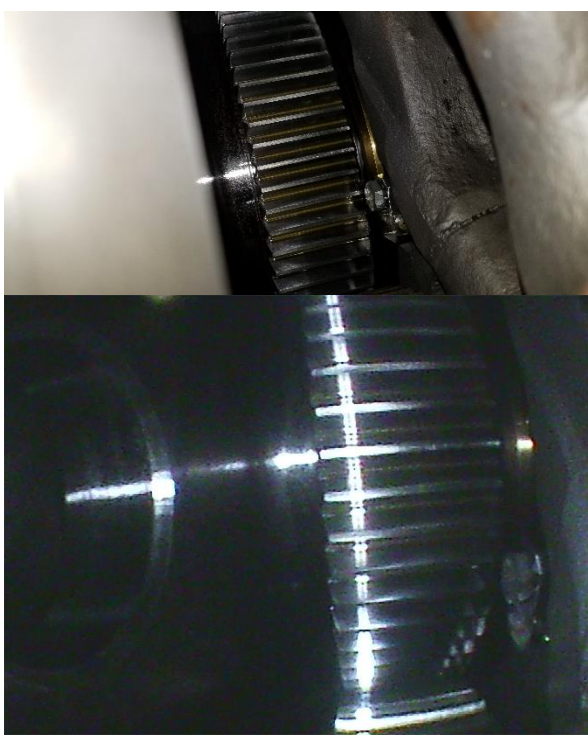
Access location Description	Picture	Inspection for	Severity / Comments
<p>A</p> <p>Main Drive Accessory</p>

<p>a)Gear wear b)Teeth damages</p>	<p>Normal Condition</p>
<p>A</p> <p>Idler Gear</p>

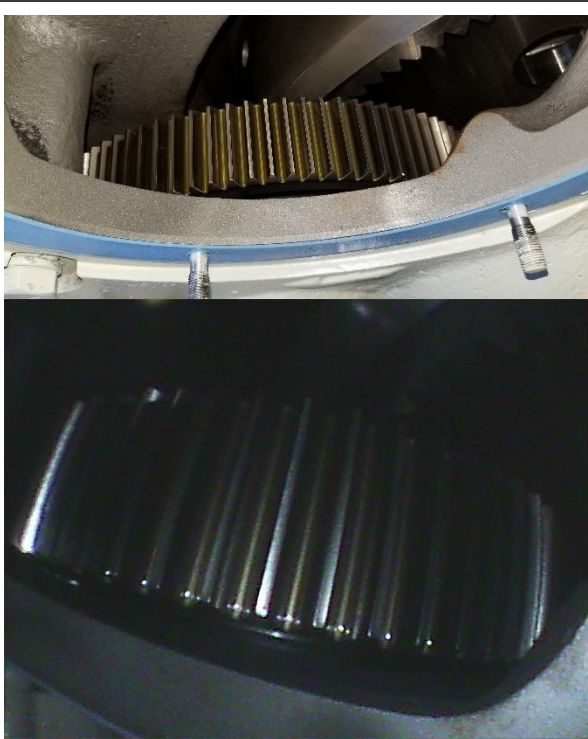
<p>a)Gear wear b)Teeth damages</p>	<p>Normal Condition</p>

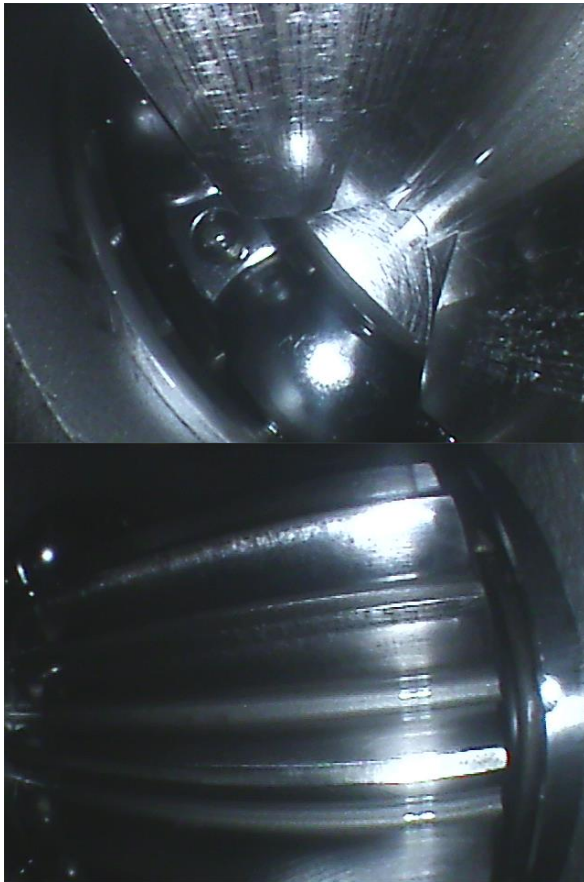
Other Accessory  
Gear

- a) Gear wear
- b) Teeth damages

Normal Condition

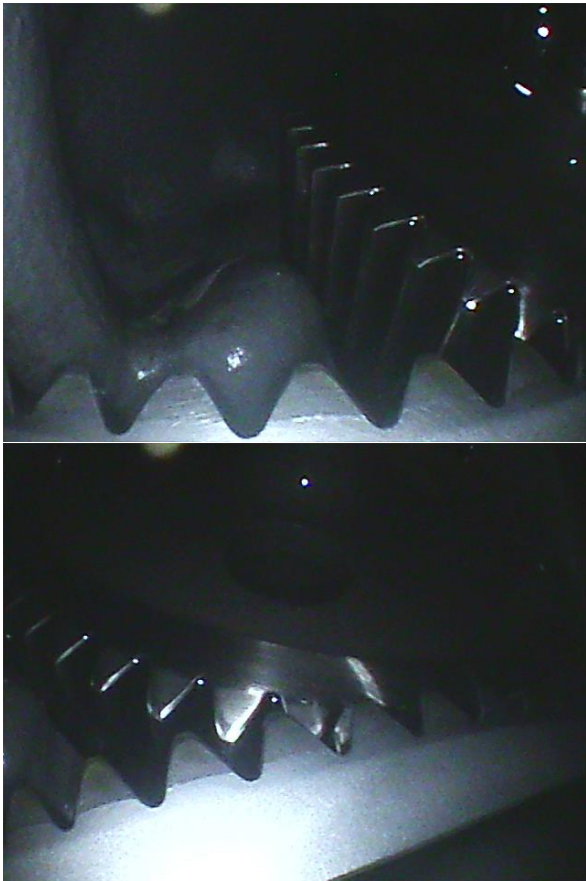
Access location Description	Picture	Inspection for	Severity / Comments
A  Large Low Speed Brg	 	a) Gear wear b) Teeth damages	Normal Condition

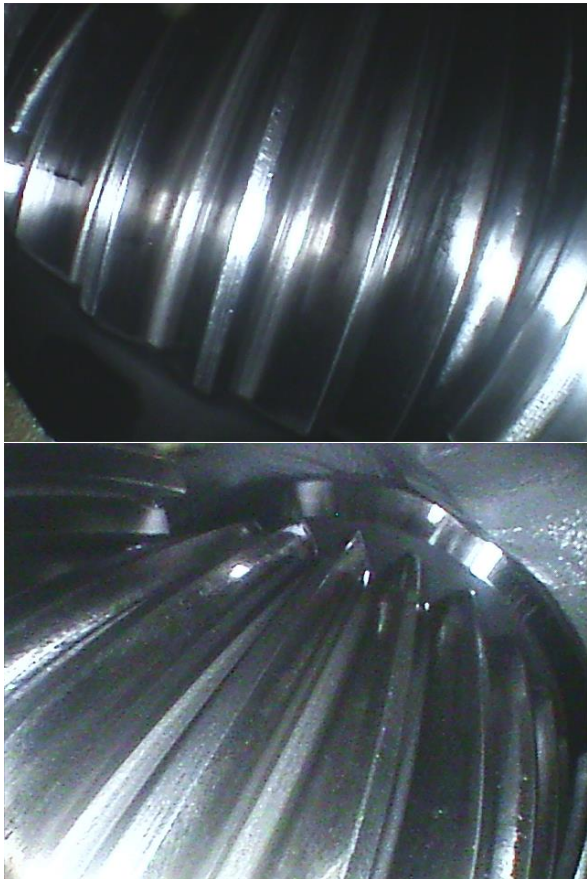
Access location Description	Picture	Inspection for	Severity / Comments
A  Pinion Helical Gear

a) Gear wear b) Teeth damages	Normal Condition

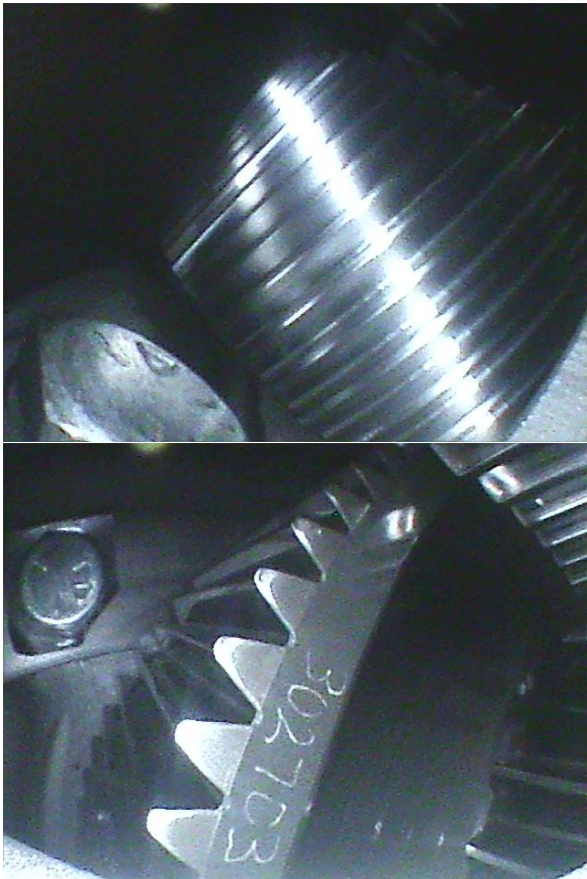
Access location Description	Picture	Inspection for	Severity / Comments
A  1st Stage Star Gear

a) Gear wear b) Teeth damages	Normal Condition

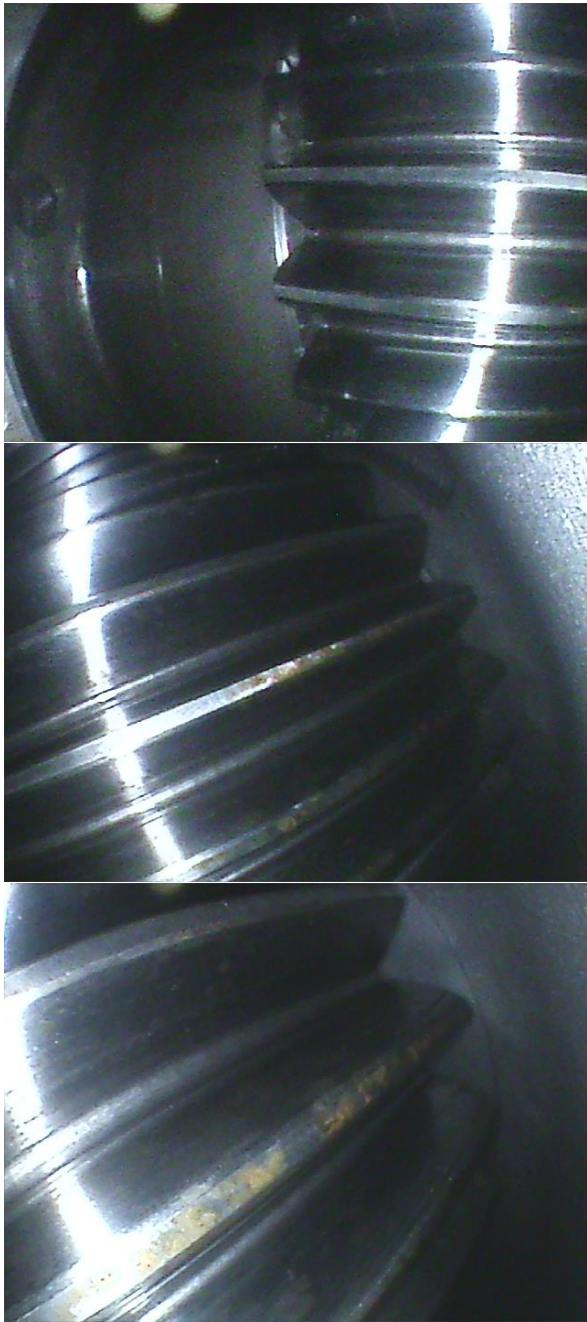
Access location Description	Picture	Inspection for	Severity / Comments
A  2nd Stage Star Gear

a) Gear wear b) Teeth damages	Normal Condition

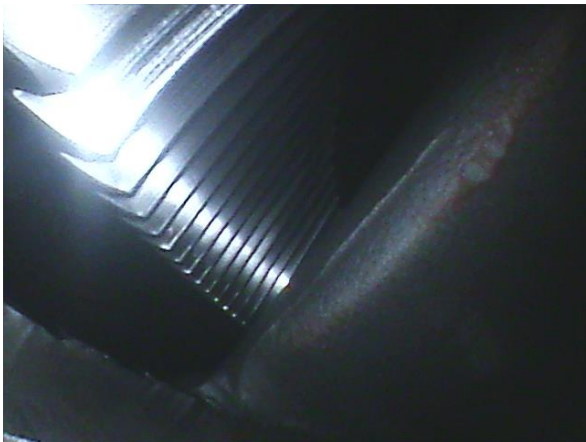
Access location Description	Picture	Inspection for	Severity / Comments
A Ring Gear

a)Gear wear b)Teeth damages	Normal Condition

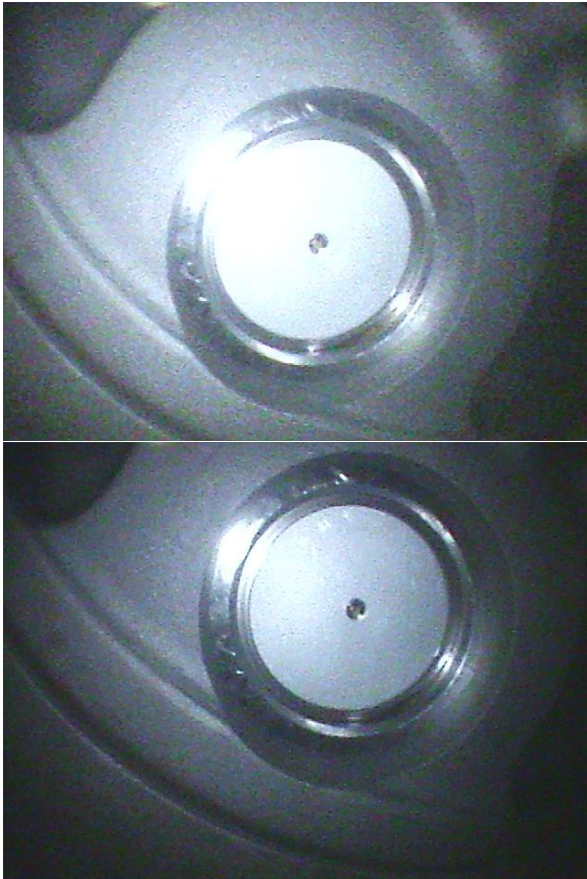
Access location Description	Picture	Inspection for	Severity / Comments
B Bearing Cap

a)Color change	Normal Condition

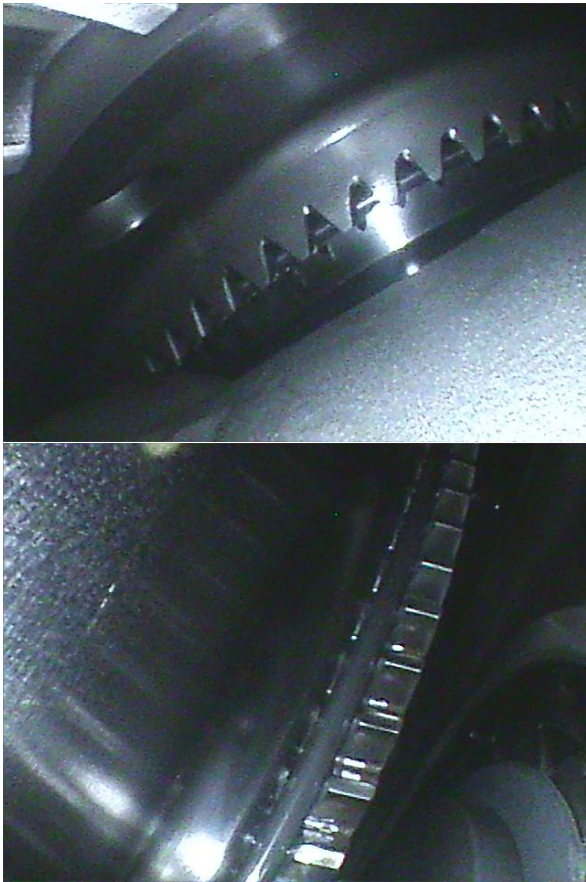
Access location Description	Picture	Inspection for	Severity / Comments
A Retainer Rings

a)Wear b)Cracks c)Wire dislodgement from groove	Normal Condition
A Thrust Washers

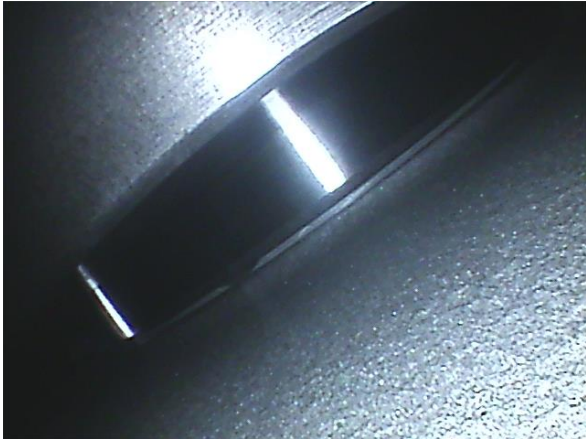
a)Wear b)Scoring c)Cracks	Normal Condition
