SITE ACTIVITY REPORT

Customer Name	SOENERGY INTERNATIONAL INC	FE Name	Cesar Jimenez
Site Name	WEST TEXAS	W.O. Nr.	W1061439239
Contact Name	Javier Londono	W.O. Start / Finish	9/23/2019 to 9/27/2019
PO / Contract Nr.		Report Date	10/30/2019

The purpose of this visit was to assist the customer with the engine exchange of the TG01951 Unit.

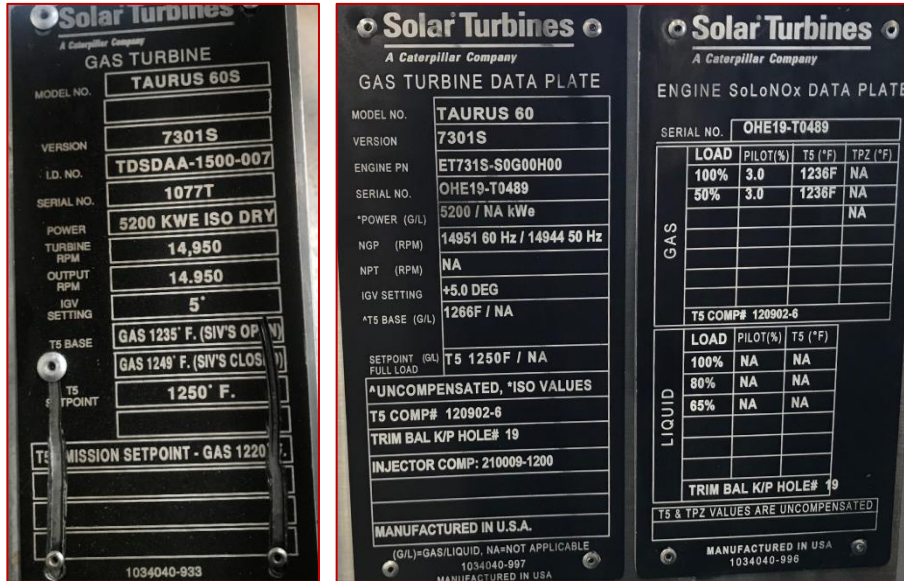
Figure 1. Engine tags of engine to be removed (left) and new engine (right).

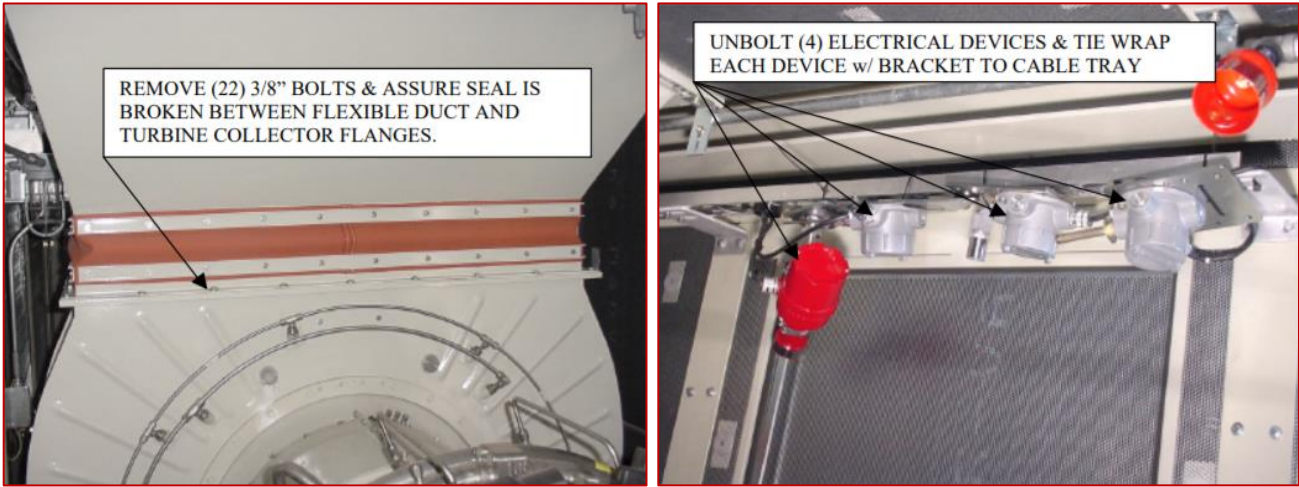
Figure 2. Enclosure internal preparations for ceiling removal.

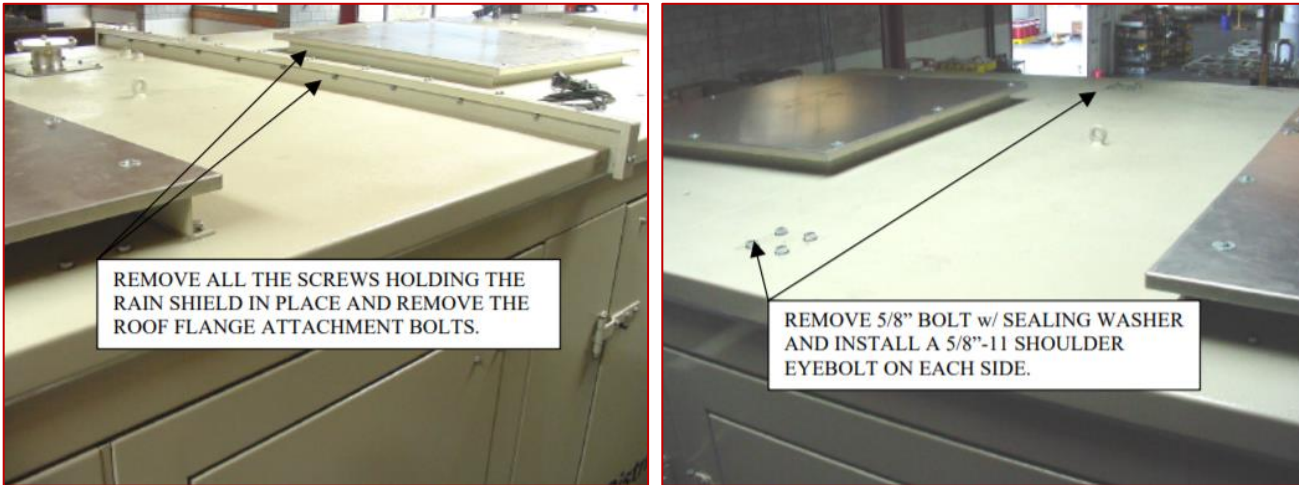
- o Ceiling bolts were removed as shown in images below.

Figure 3. Exterior preparations.

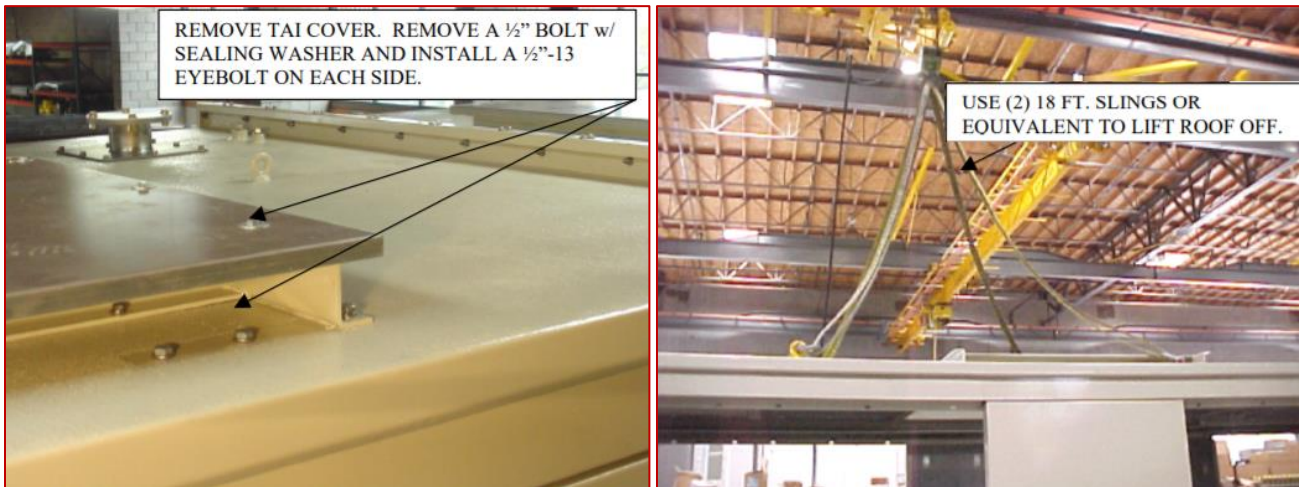
- o Lastly, covers on top were removed to install eye bolts for lifting.

Figure 4. Ceiling lifting preparations.

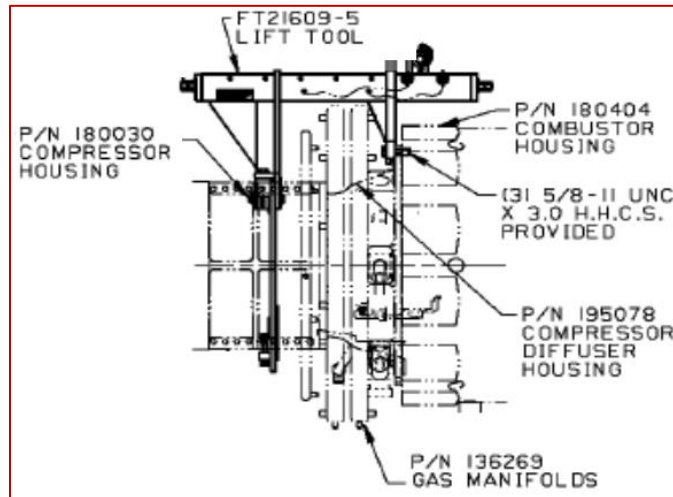
- Once ceiling had been removed, engine tubing connections and electrical lines were disconnected to prepare for engine removal.
- Exhaust collector was removed to create more space for the engine removal.
- Engine was removed using field tool FT21609, shown in image, for single point lifting.

Figure 5. Engine single point lift tool, FT21609.

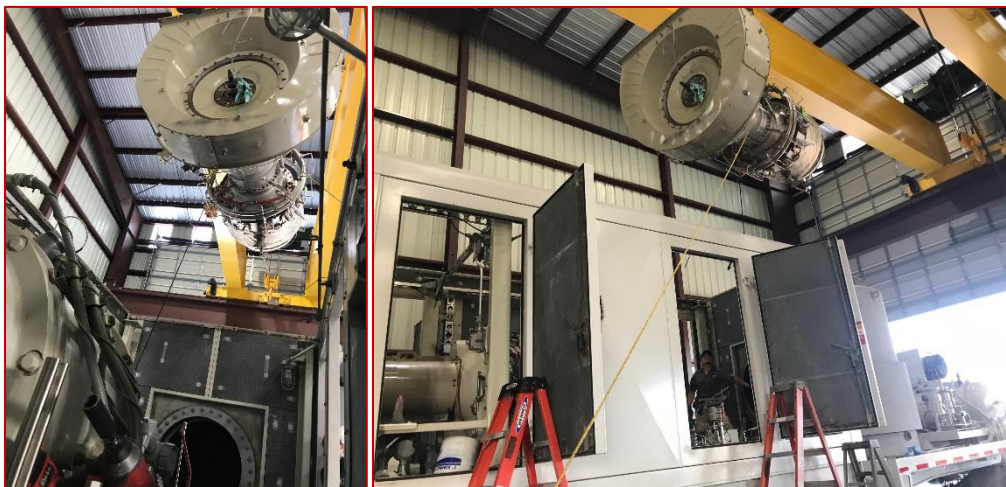
- Once the lifting tool had been mounted and some tensioning was applied, the engine bolts to the RGB were removed and POGO stick was loosened. Engine was then lifted out of the enclosure as shown in image.

Figure 6. Engine lifting method.

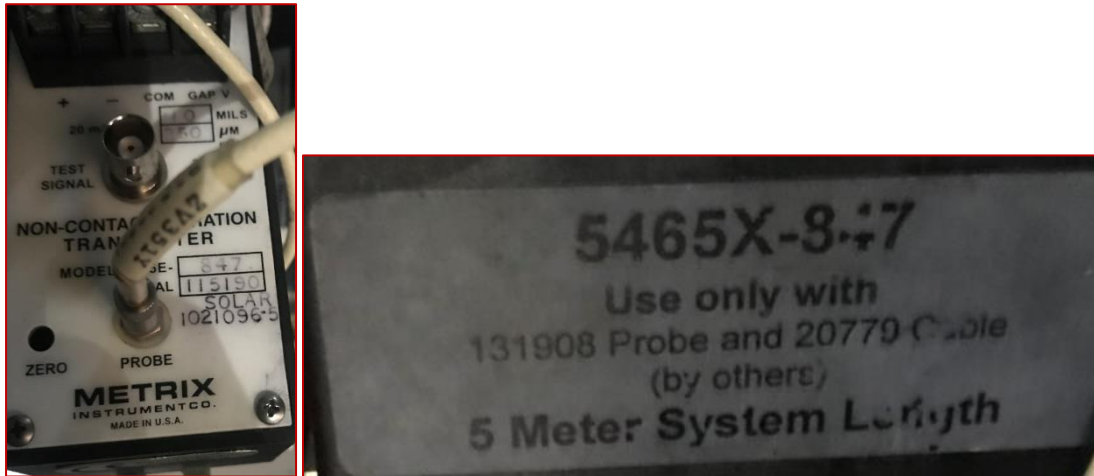
- Engine was secured on the shipping stand and all fittings were transferred to the new engine. Inlet collector was also transferred using new hardware. Mating surfaces were sealed using RTV.
- While inspecting the new engine to prepare for installation, it was realized that the new engine came with newest vibration system probes. This was going to be an issue because the unit was using the old Metrix vibration system, which was incompatible.

Figure 7. Old vibration system.

- According to Tech Letter TL5.4/124B. The Metrix system was obsolete and had been displaced by a CEC vibration monitoring system. This is shown in image below.

- After following the new part number presented here it was discovered that it had been displaced by a newer model, which is shown in image below. For the 5-meter system being used for bearing 1, the new transmitter was PN 1086387-202 with extension cable PN 190816-30. For bearings 2 and 3, the new transmitters were PN1086387-302 with extension cable PN 190816-70 (shown as 2 of each in image).

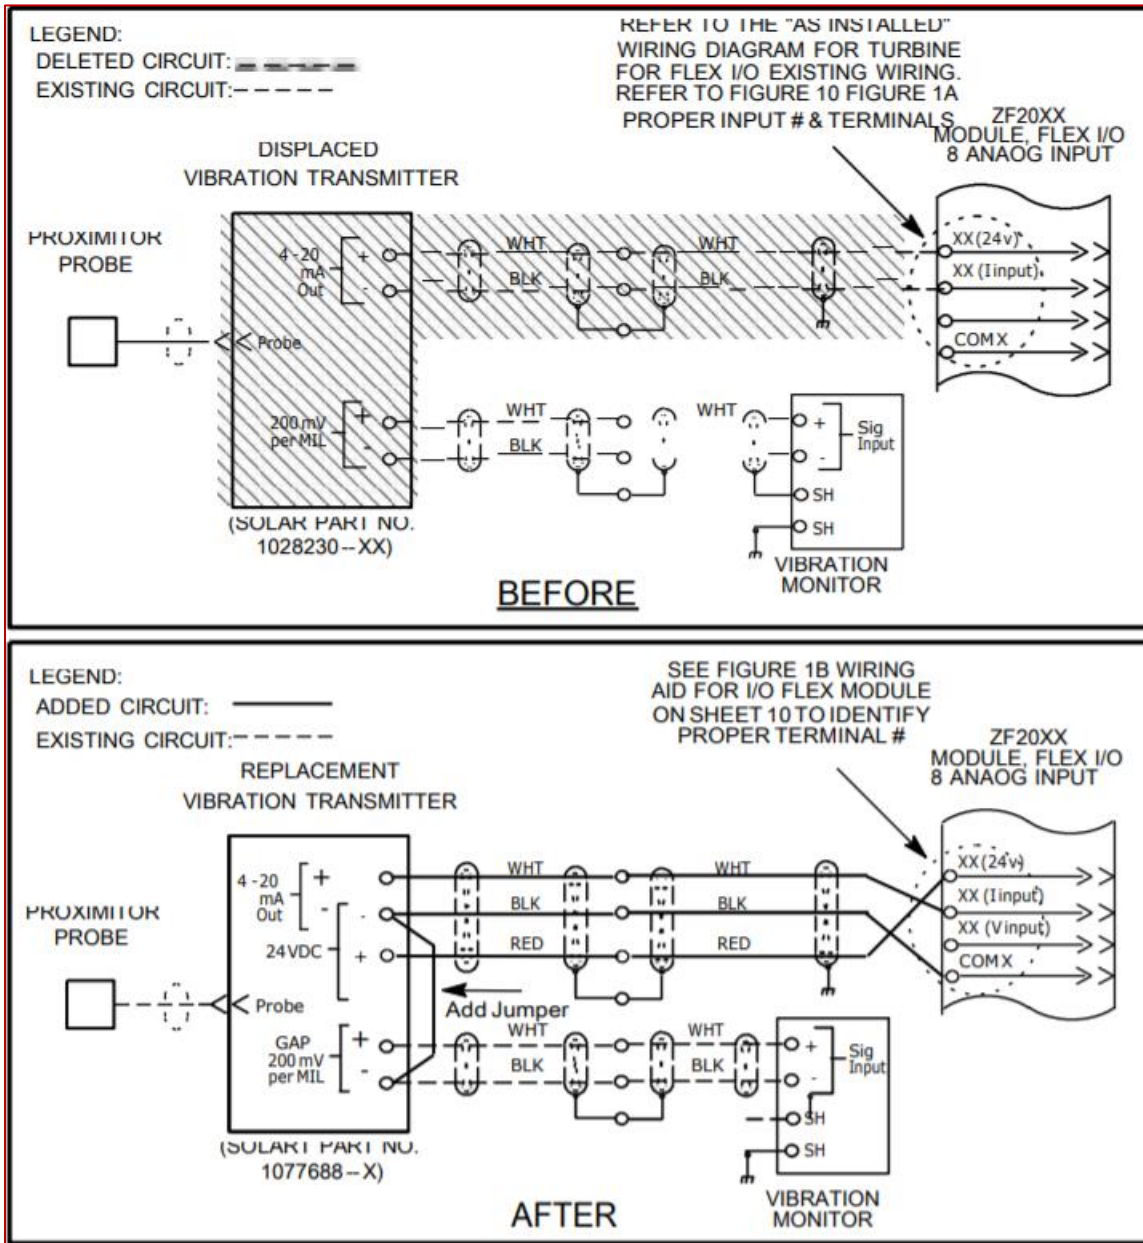
- With the new transmitters, some wiring modifications needed to be made because a power cable was required for the new models. This is shown in Figure 10.

Figure 10. Wiring modifications necessary for the new vibration transmitters.
